Manhole Inspection Summary

Manhole # S17G__042MH

Insp Date: **1/24/09 1:33 PM**

Location Address: **114 N WHEELER AVE** Cross Street: **W FAYETTE ST**

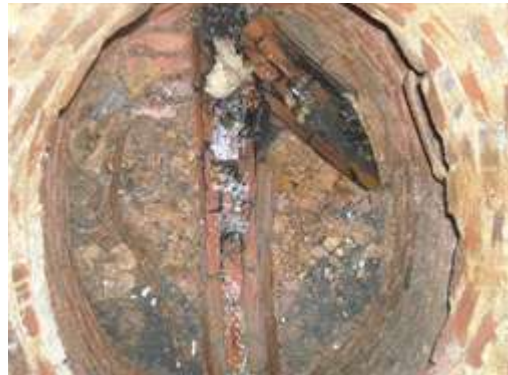
Top View

Comments **REMOVAL OF COVER REQUIRED POUNDING WITH 16LB SLEDGE TO BREAK OPEN LID. SPECIALTY CLEANING WAS REQUIRED. BROKEN LID REPLACED. INSPECTION COMPLETED.**
